Manhole Inspection Summary

Manhole # S55AA_007MH

Insp Date: **12/23/08 1:58 PM**

Location Address: **side 3800 pulaski hw**

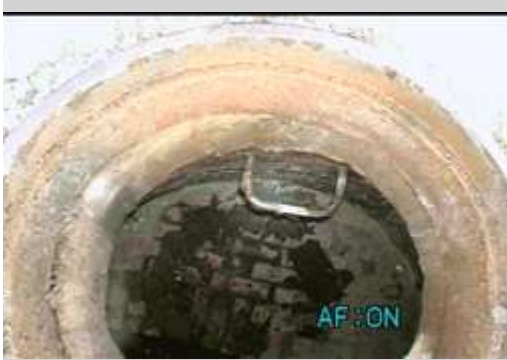
Defect 2

Steps Count: **1** Missing: **0** ☒ **Corroded**

corr step

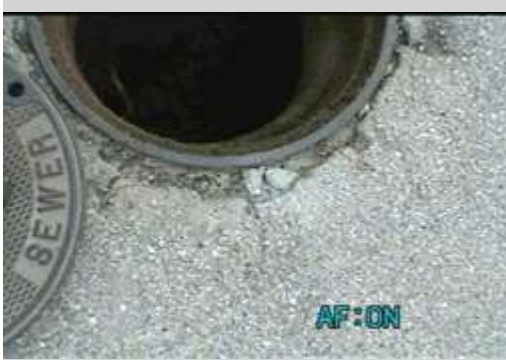
Defect 1

deteriorated grade

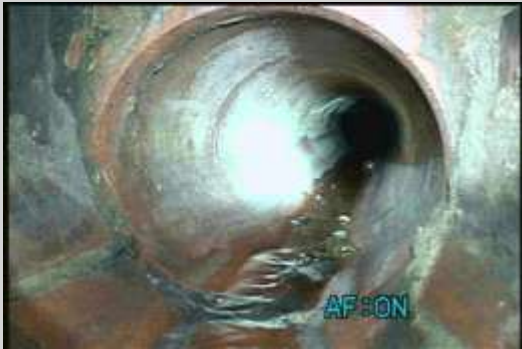
12 O'Clock Outflow

8 in. Circular Gravity Sewer
Pipe Out @ 12 O'Clock

Invert Depth: **4.88** (ft.) Flow Characteristics: **Slow**

Infiltration: **None**

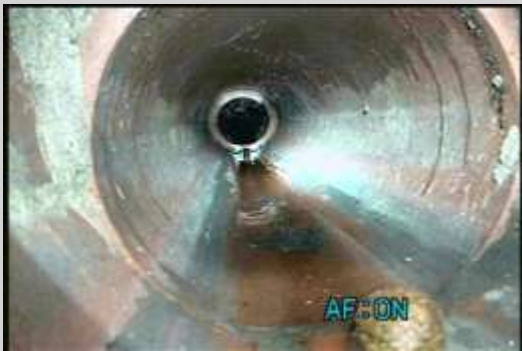
9 O'Clock Inflow

8 in. Circular Gravity Sewer
Pipe In @ 9 O'Clock

Invert Depth: **4.83** (ft.) Flow Characteristics: **Slow**

Infiltration: **None**
